# National Transportation Safety Board Aviation Accident Preliminary Report

<b>Location:</b>	El Cajon, CA	<b>Accident Number:</b>	WPR22FA068
<b>Date &amp; Time:</b>	December 27, 2021, 19:14 Local	<b>Registration:</b>	N880Z
<b>Aircraft:</b>	GATES LEARJET CORPORATION 35A	<b>Injuries:</b>	4 Fatal
<b>Flight Conducted Under:</b>	Part 91: General aviation - Positioning

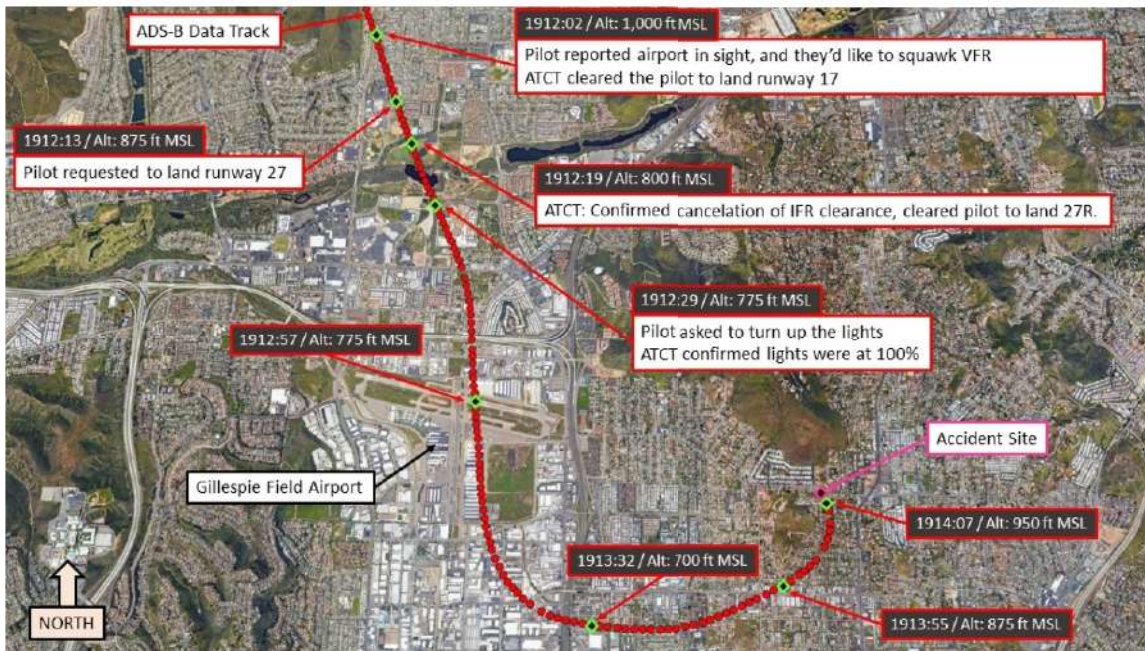
Preliminary Automatic Dependent Surveillance-Broadcast (ADS-B) data showed that after departure from SNA, the flight made a left turn out over the waters of the Pacific Ocean and flew generally south – southeast along the coast and ascended to a cruise barometric altitude of about 11,000 ft sea level (MSL). After the flight passed Carlsbad, California, the airplane turned left and began to descend toward SEE. As shown in figure 1, ADS-B data showed that the airplane overflew SEE at a barometric altitude of about 775 ft MSL (407 ft above ground level) and entered a left downwind for runway 27R. While on the downwind leg, the airplane descended to a barometric altitude of 700 ft MSL, then ascended to a barometric altitude of 950 ft MSL while on the base leg. The last recorded ADS-B target was at 1914:09, at a barometric altitude of 875 ft MSL.

Figure 1: Recorded ADS-B data with ATCT communication annotations.
