COASTAL EROSION ASSESSMENT AND
CAVE SOLUTION FEASIBILITY ANALYSIS
**COAST BOULEVARD AND
COOK'S CRACK SEA CAVE**
SAN DIEGO, CALIFORNIA

Project No. 2086B
June 17, 2019

GEOTECHNICAL SURVEY AND EVALUATION
COOK'S CRACK SEA CAVE
JUNE 28, 2018
BY TERRACOSTA

Project No. 2086A
June 28, 2018

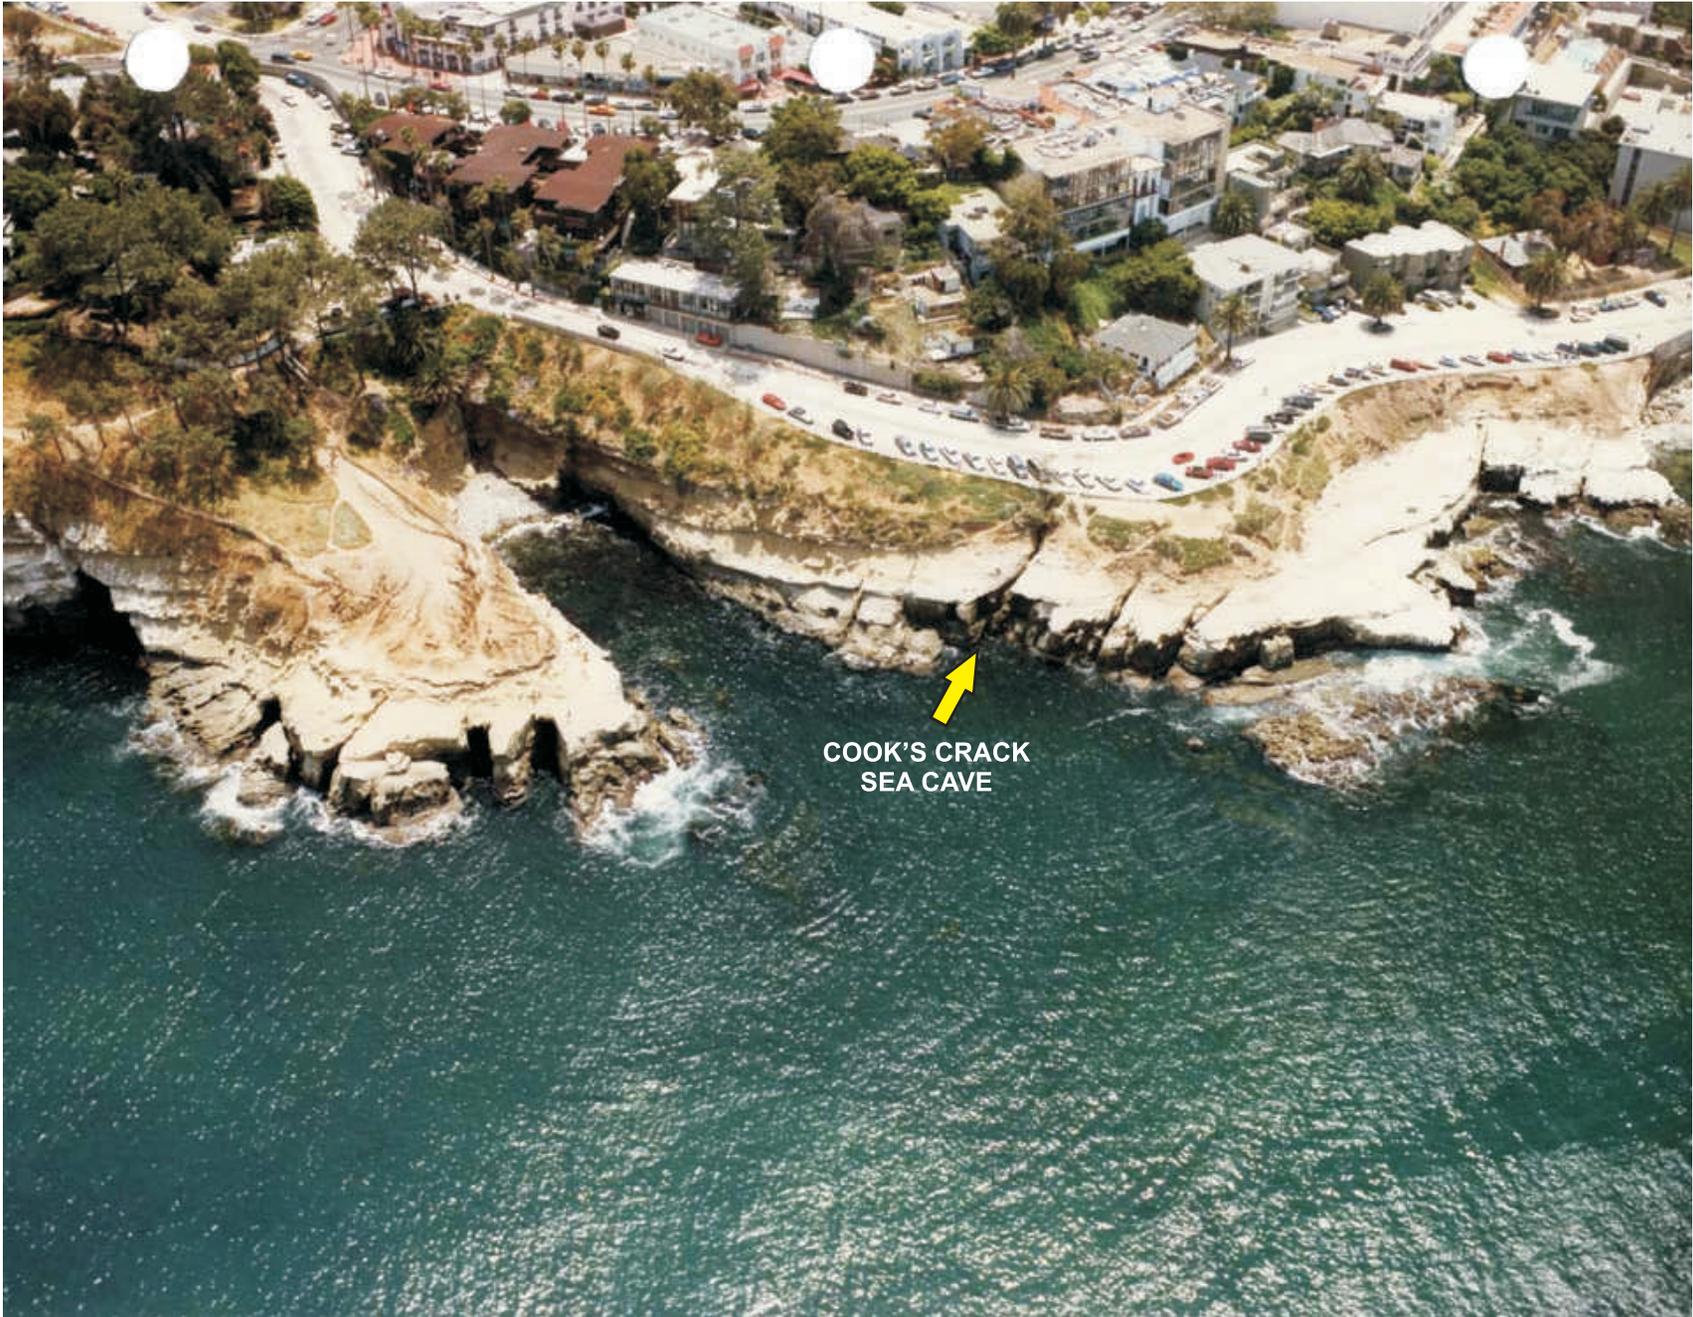
PHOTO NO.:
1

As indicated on Photo 1, the Cook's Crack Sea Cave is located on a cliffed section of the La Jolla shoreline, with the bathymetry immediately fronting the sea cave, although somewhat variable, around -3 feet MLLW. Photo 4, taken during our survey during a tidal low with the water level at about -0.2 foot MLLW, shows an indentation into the cliffed shore face of about 9 feet prior to actually entering the 4½-foot-wide mouth of the sea cave that is still not visible in Photo 4. The width of this indentation is also about 9 feet, and provides

We anticipate that the contractor would fill the cave in relatively horizontal lifts, and after the tops of the geobags have been reached, the exposed seaward face of the open jointed roof of the Cook's Crack Sea Cave (see Photo 1) would then be architecturally shaped to blend in with the surrounding formational bedrock to recreate the architectural appearance of the faulted roof rock. Once the cave is filled, the ten to twelve 4-ton rocks could be lifted back out of the mouth of the cave, returning the cliffed section to that shown in Photo 4.

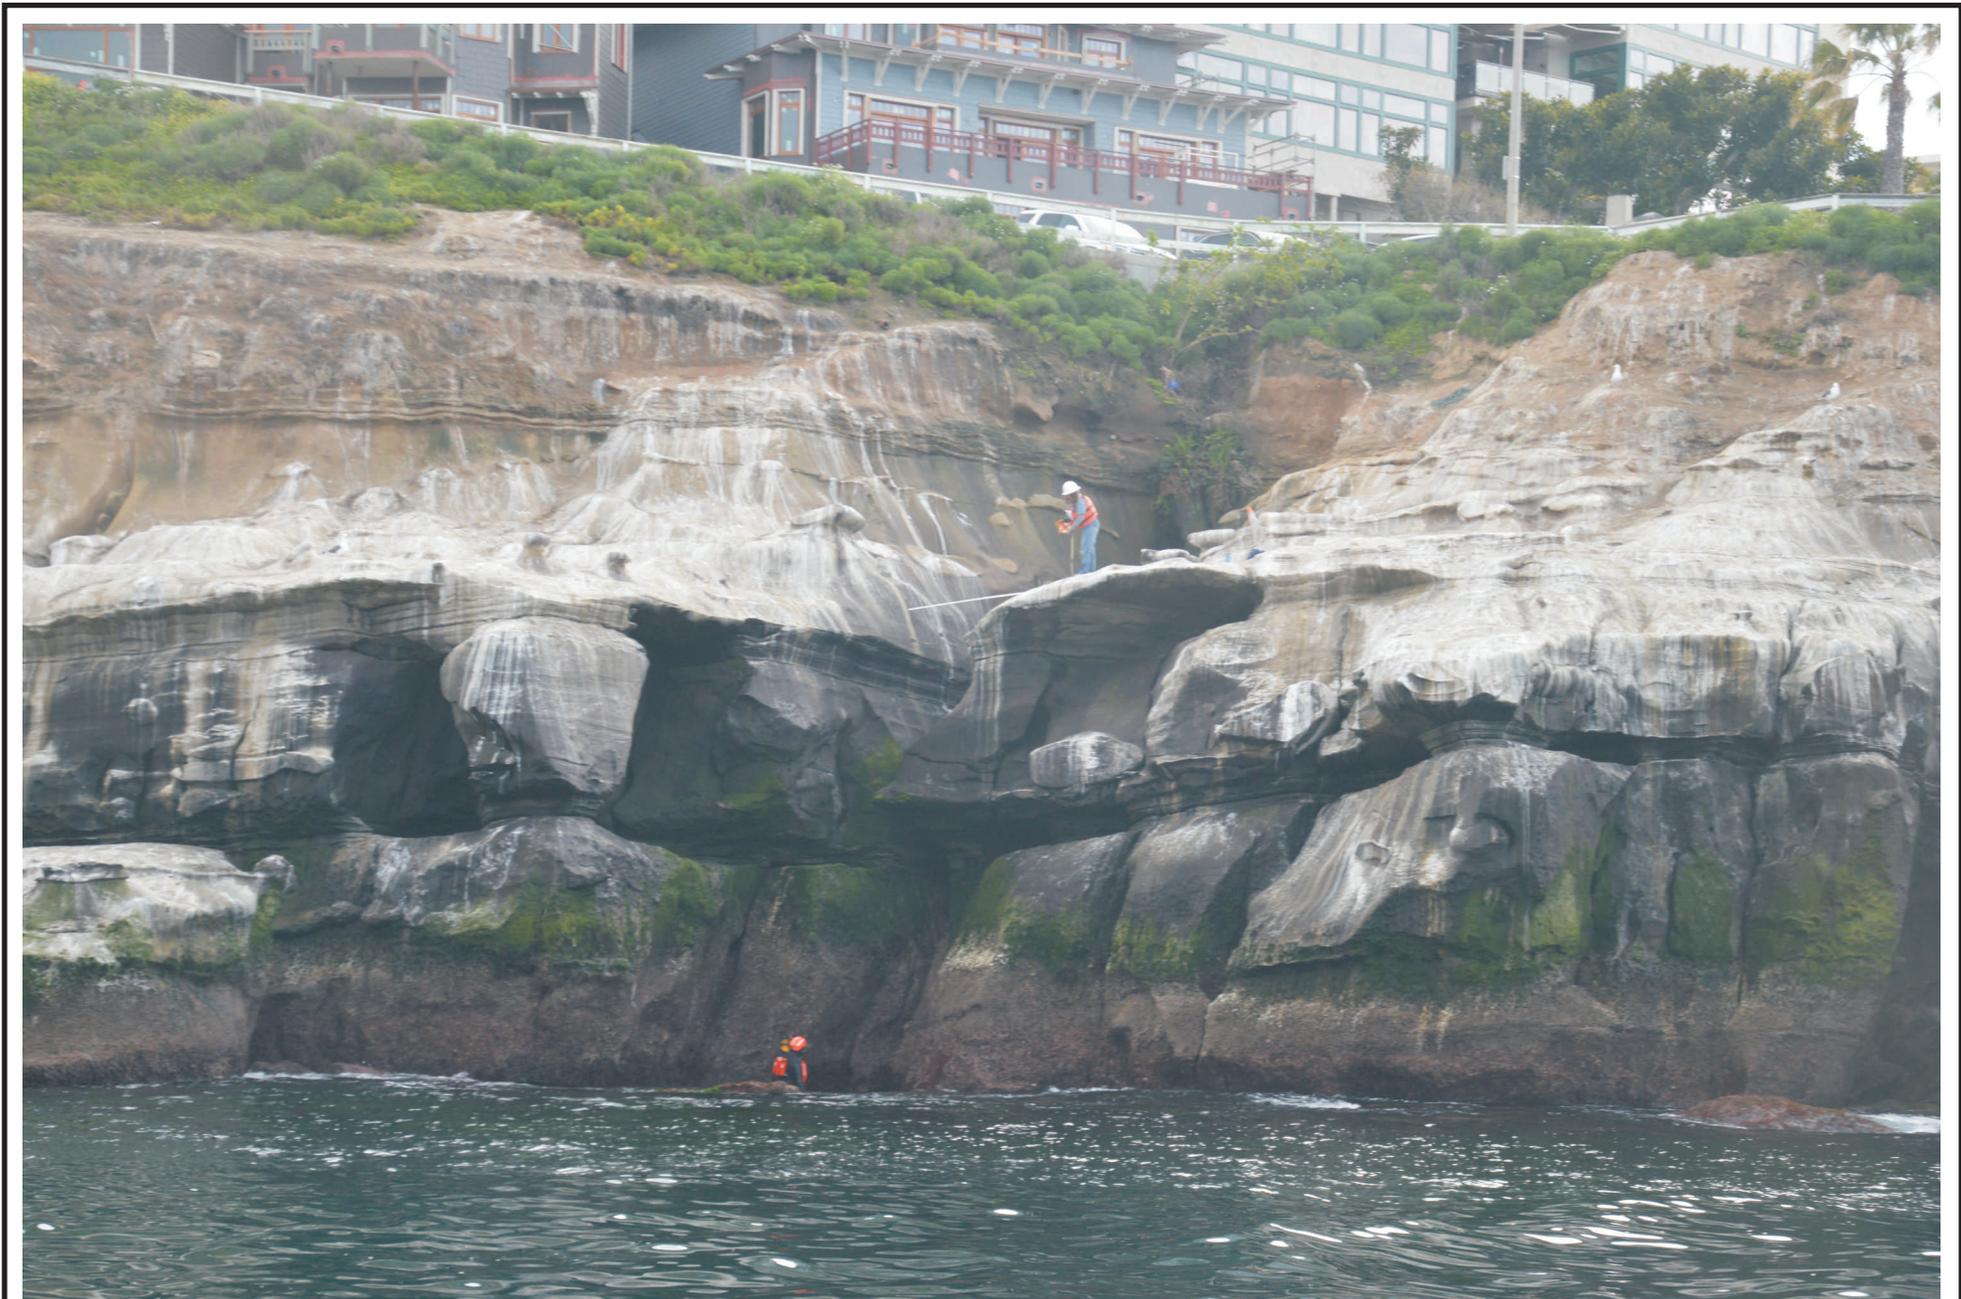
PHOTO NO.:
4

As indicated on Figure 4, the face of the concrete plug would coincide with the approximate back of the depressed area along the sea cliff, as shown on Photo 4, with the actual completed plug not even visible from the perspective of Photo 2. We propose that the plug be filled utilizing concrete-filled 2 cubic yard geobags, for which we are recommending GT1000MB geobags (product literature provided in Appendix B). The front face of the geobags would be positioned to coalign with the back of the indentation within the coastline, then backfilled with a non-reinforced erodible concrete mix consisting of two sacks of cement with 200 pounds of fly ash per cubic yard of erodible concrete. We have utilized this mix design to fill-in several sea caves, and the mix provides both a pumpable and low strength mix that should roughly approximate the strength of the Point Loma formational shelf rock.

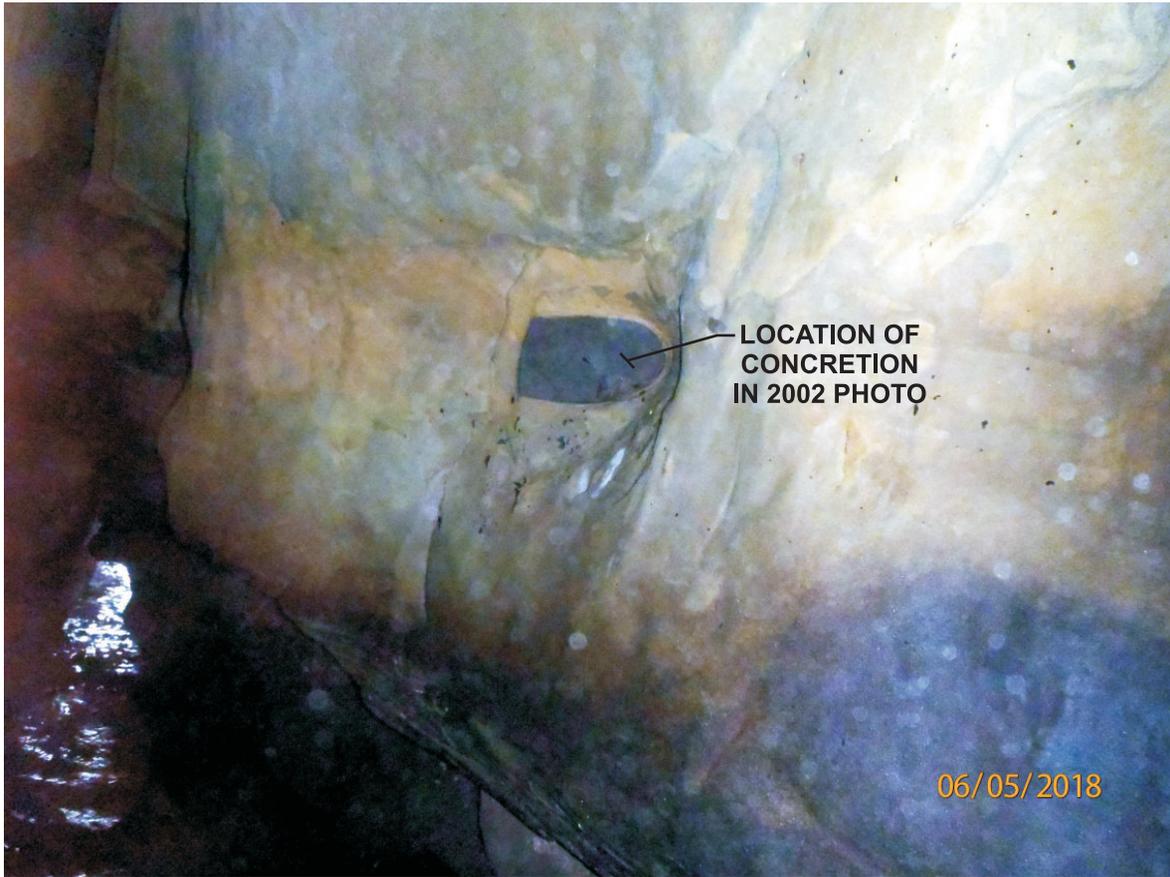
PHOTO 2: NOTE LARGE CONCRETION IS GONE, AND WALLS HAVE ERODED BACK AND WIDENED.

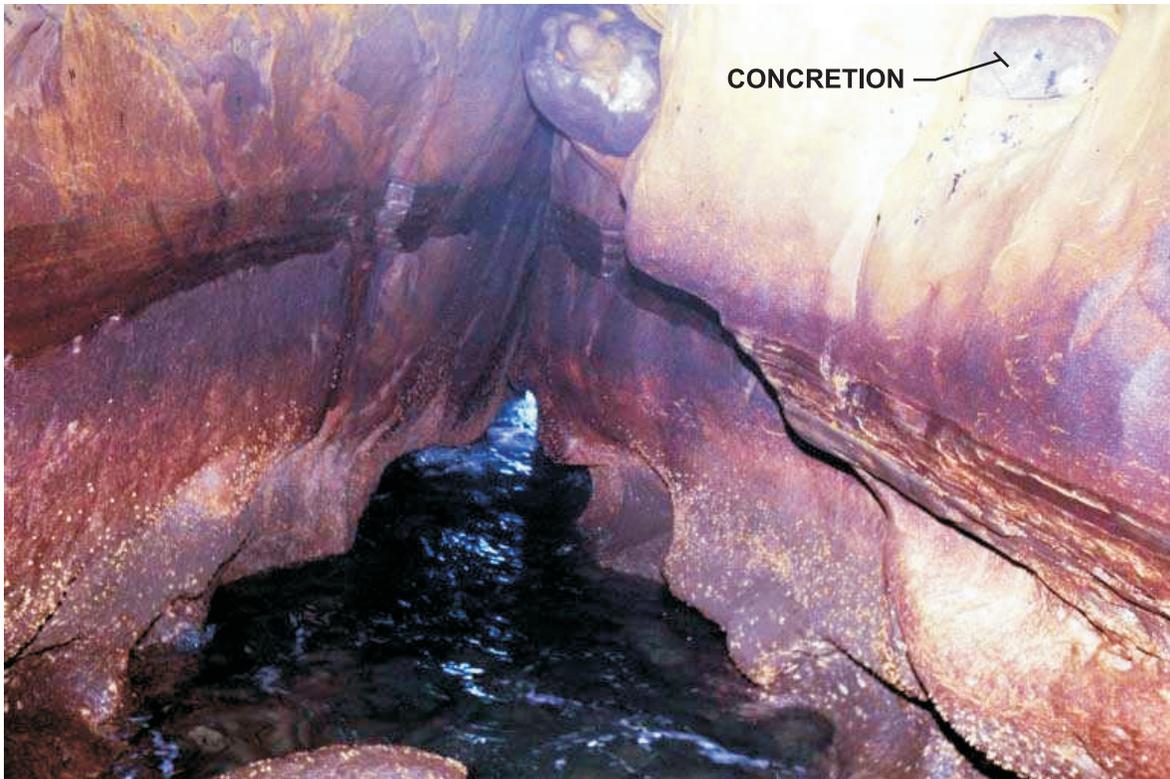
PHOTO 2A: (2002) LOOKING OUT. NOTE EXISTING CONCRETION AT UPPER EDGE OF PHOTO.

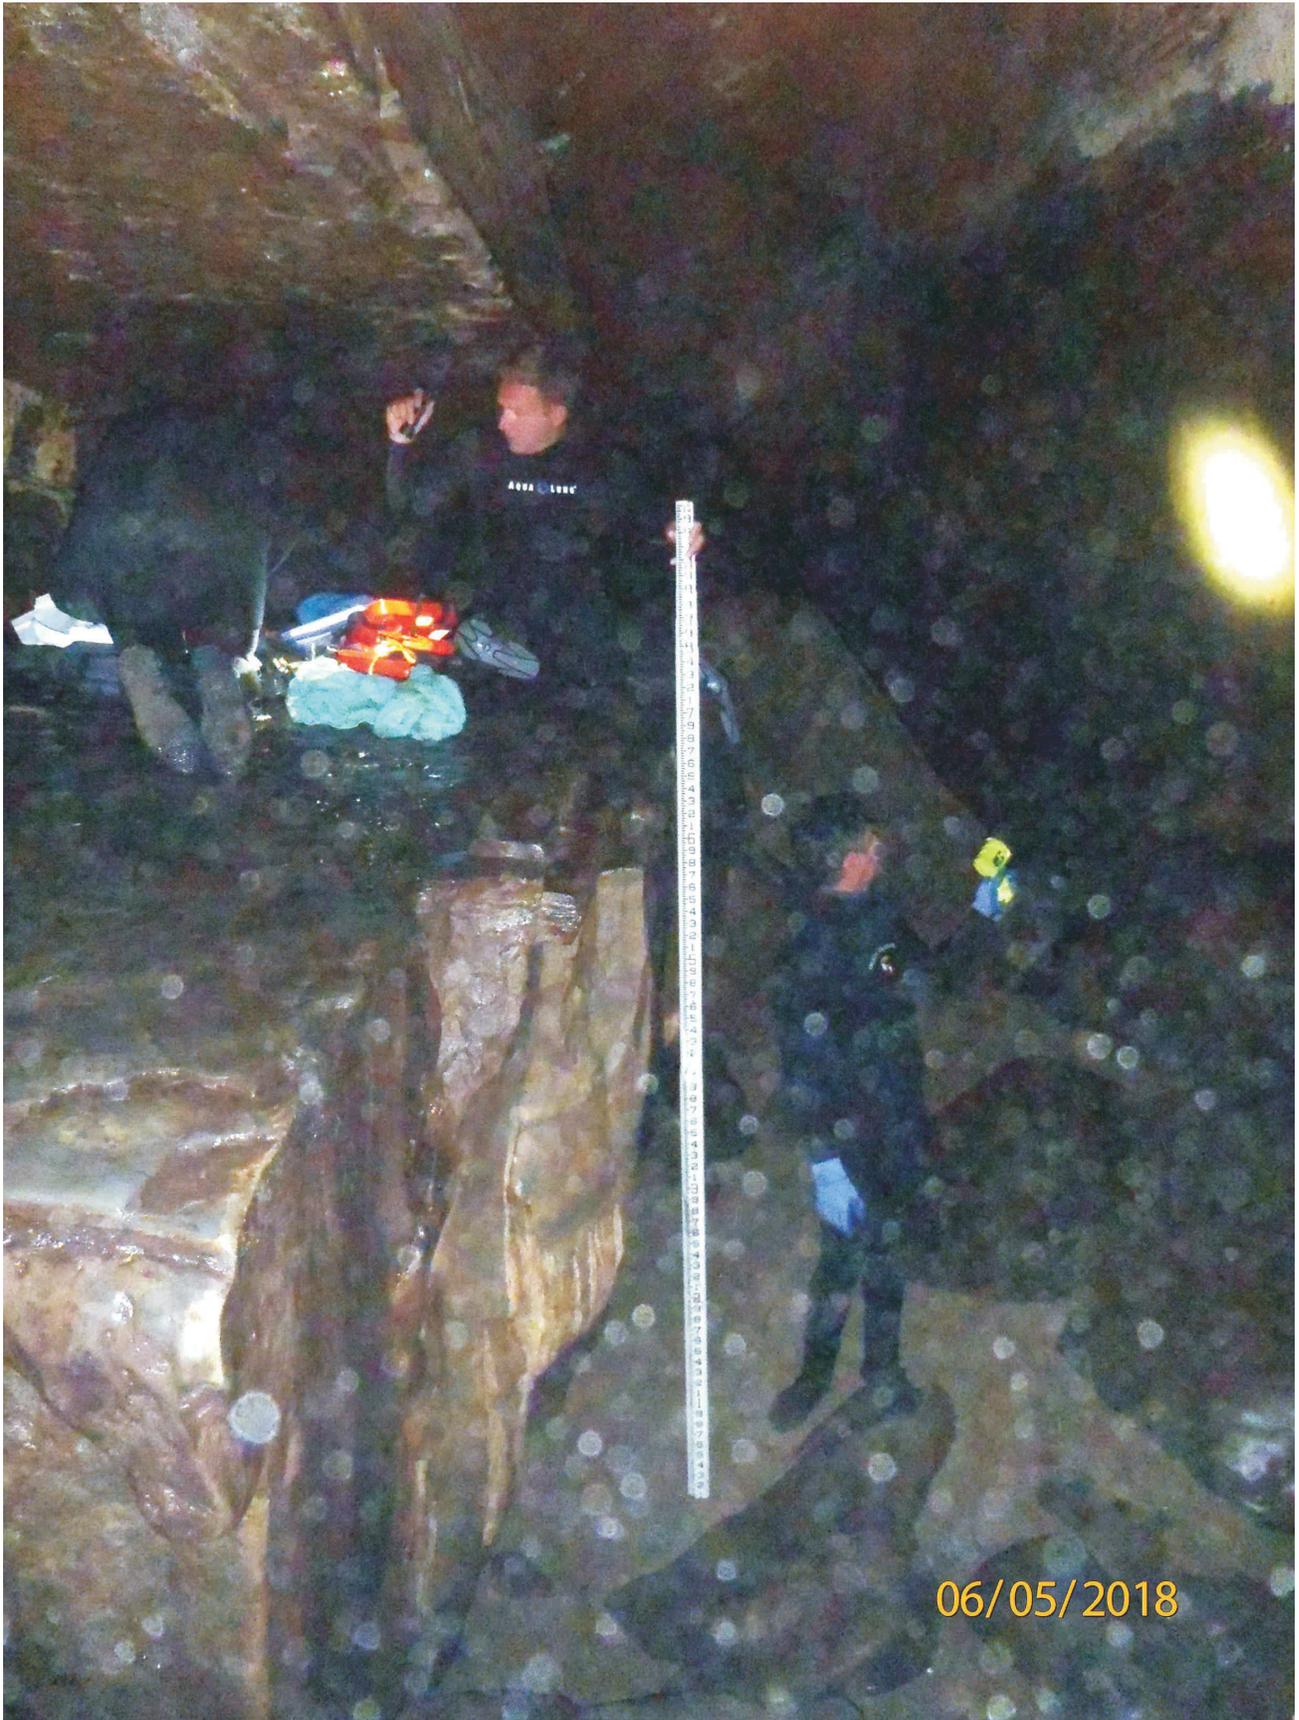
PHOTO NO.:
3

PHOTO 3: MAIN BLOCK SEEN IN 2002 SURVEY STILL MOSTLY INTACT. A CAVITY HAS DEVELOPED, UNDERMINING THE SOUTHERLY SIDE OF THE BLOCK.

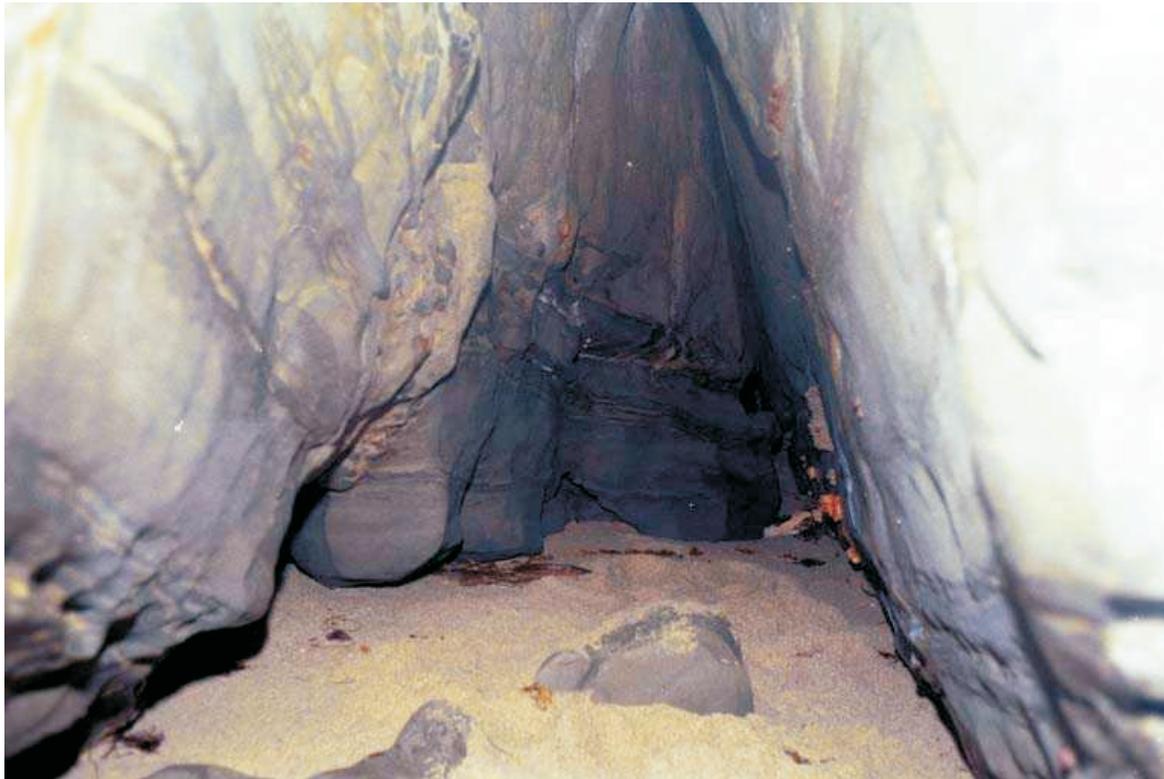
PHOTO 4: TAKEN IN 2002.

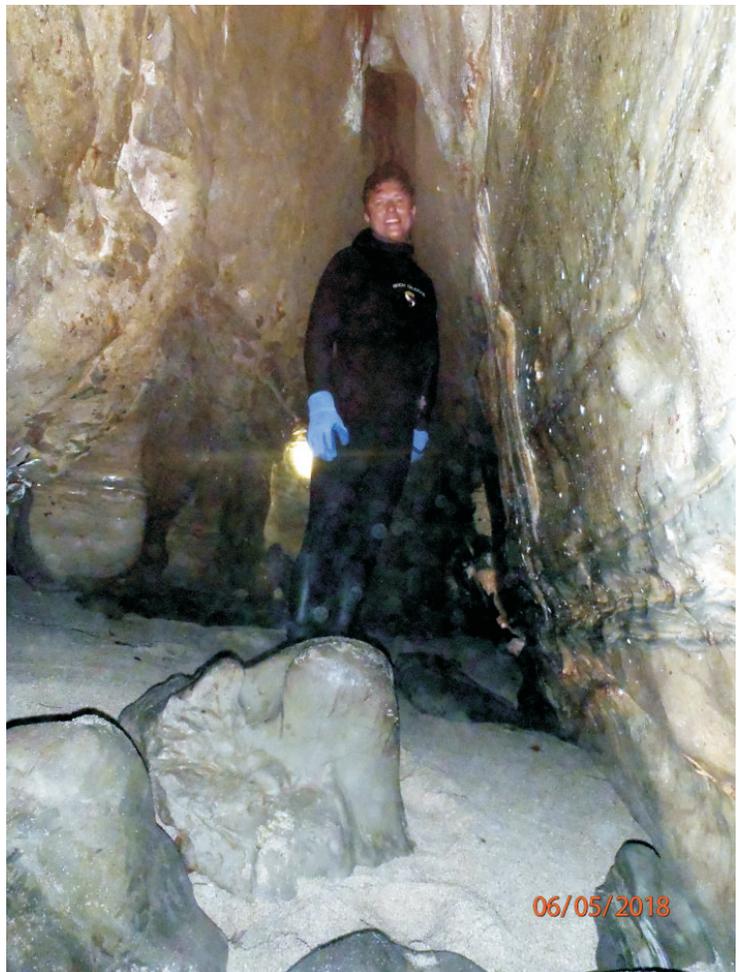
PHOTO 4A:
NOTE SAND LEVEL HAS DROPPED 1.5 TO 5 FEET.

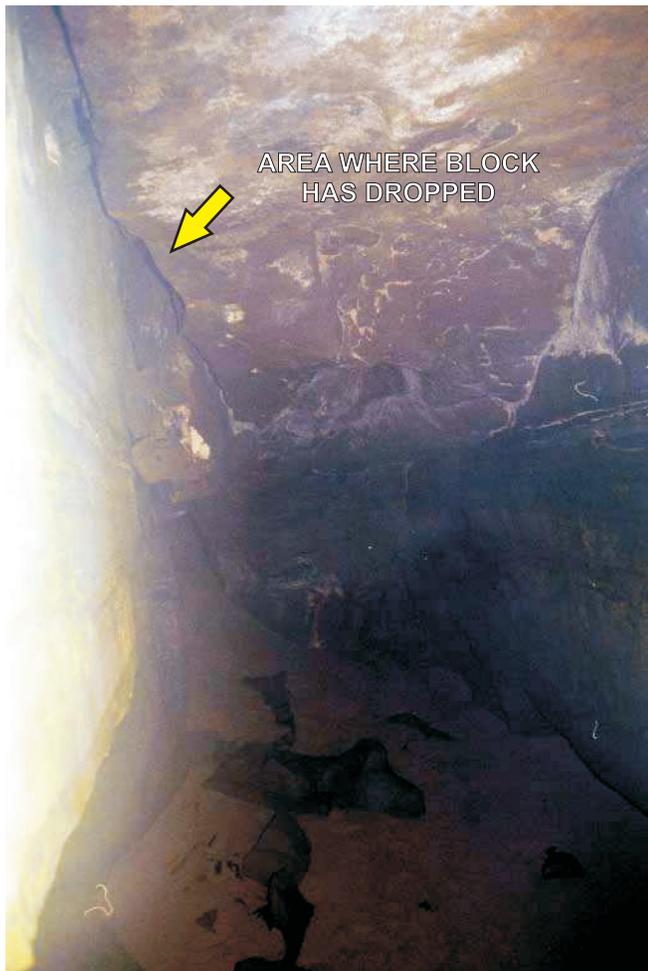
AREA WHERE BLOCK
HAS DROPPED

*PHOTO 5: (2002) NOTE AREA PRIOR TO RECENT ROOF
BLOCK FAILURE.*

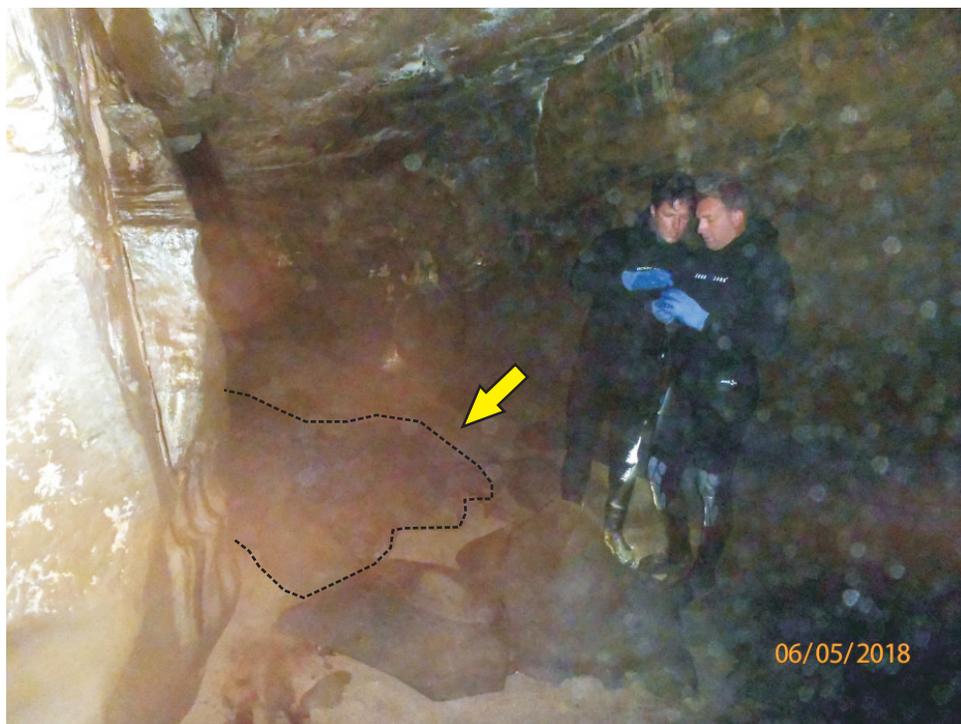
PHOTO 5A: NOTE APPARENT RECENT ROCK DEBRIS (ARROW).

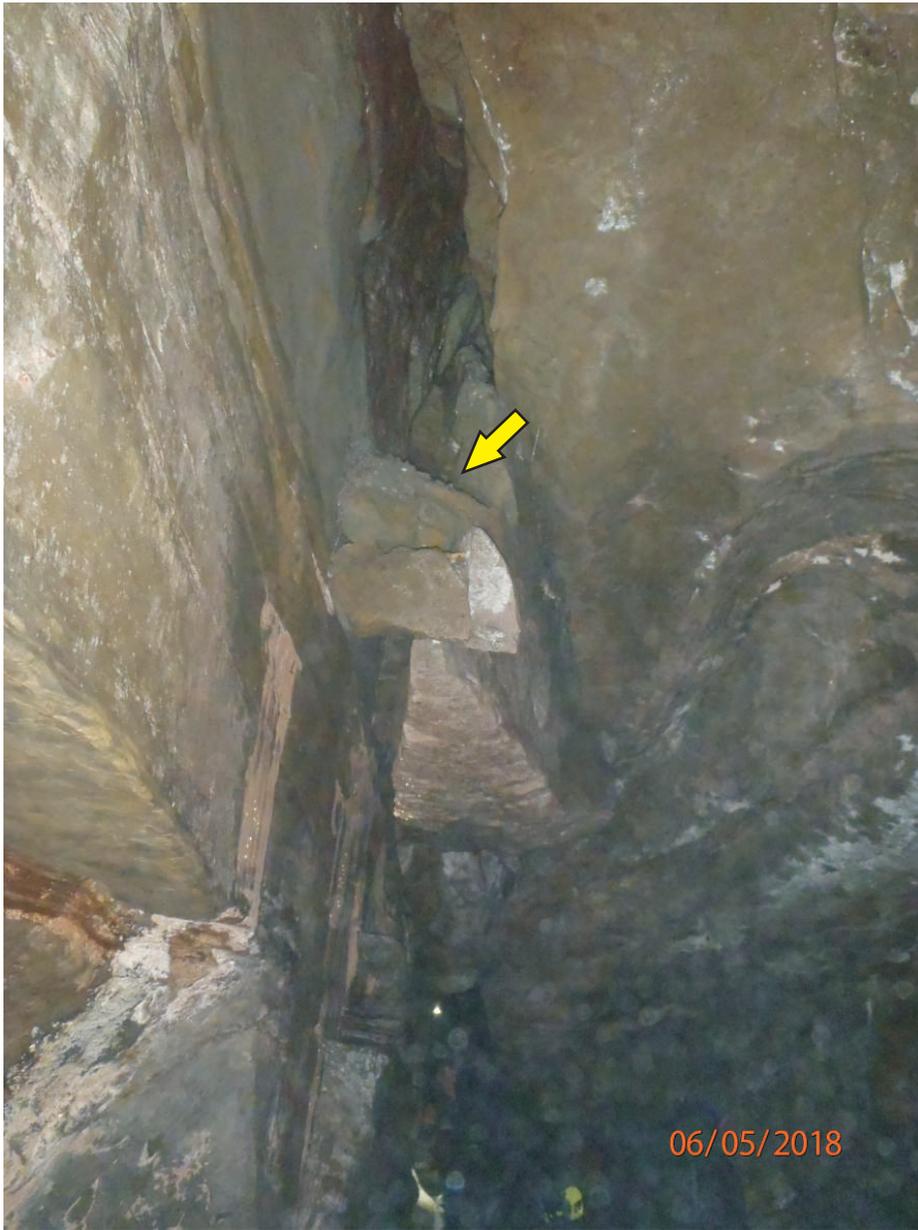
PHOTO 6: ARROW INDICATES DOWN DROPPED BLOCK. NOTE SAND ON TOP OF BLOCK.

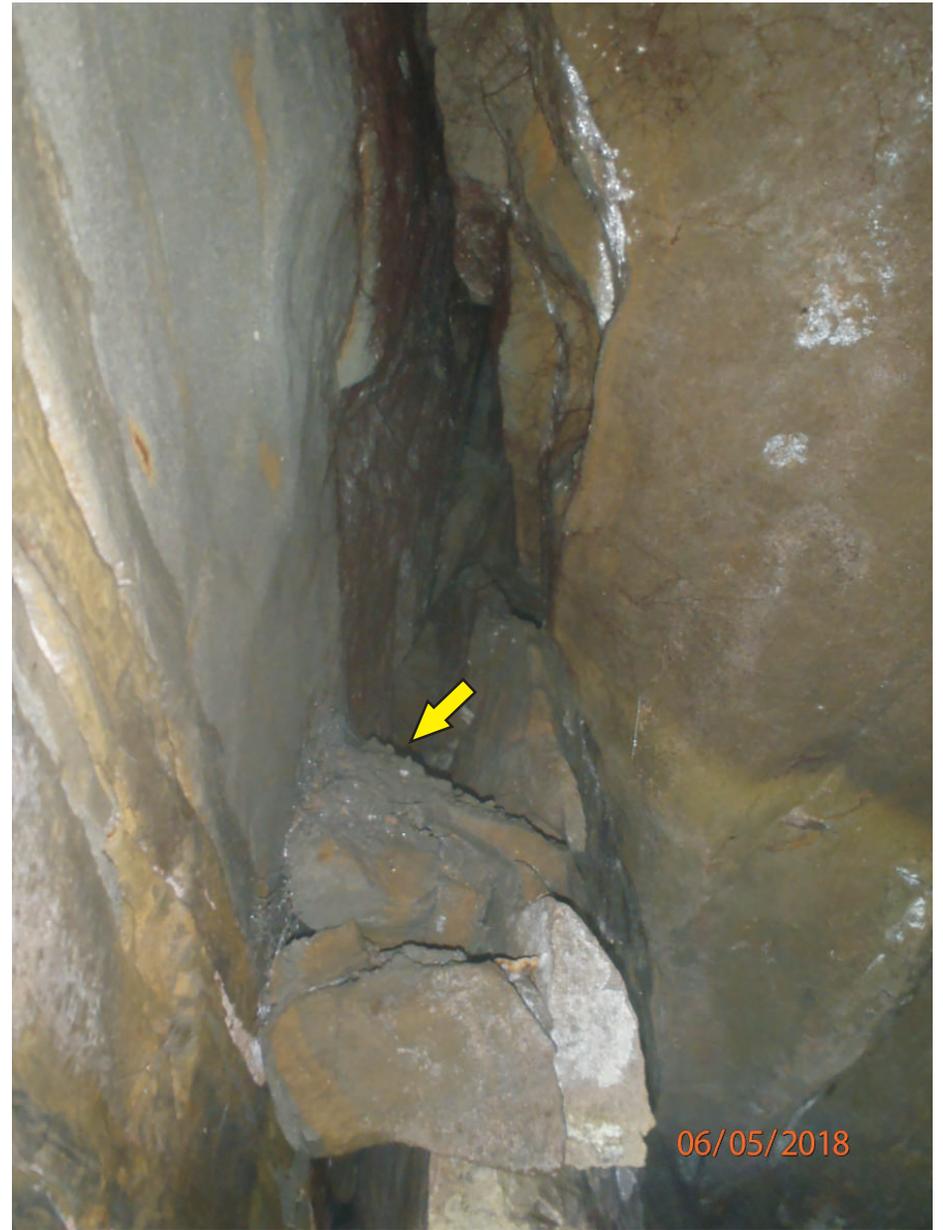
PHOTO 6A: NOTE SAND PIPING FROM OVERLYING TERRACE DEPOSITS (ARROW).

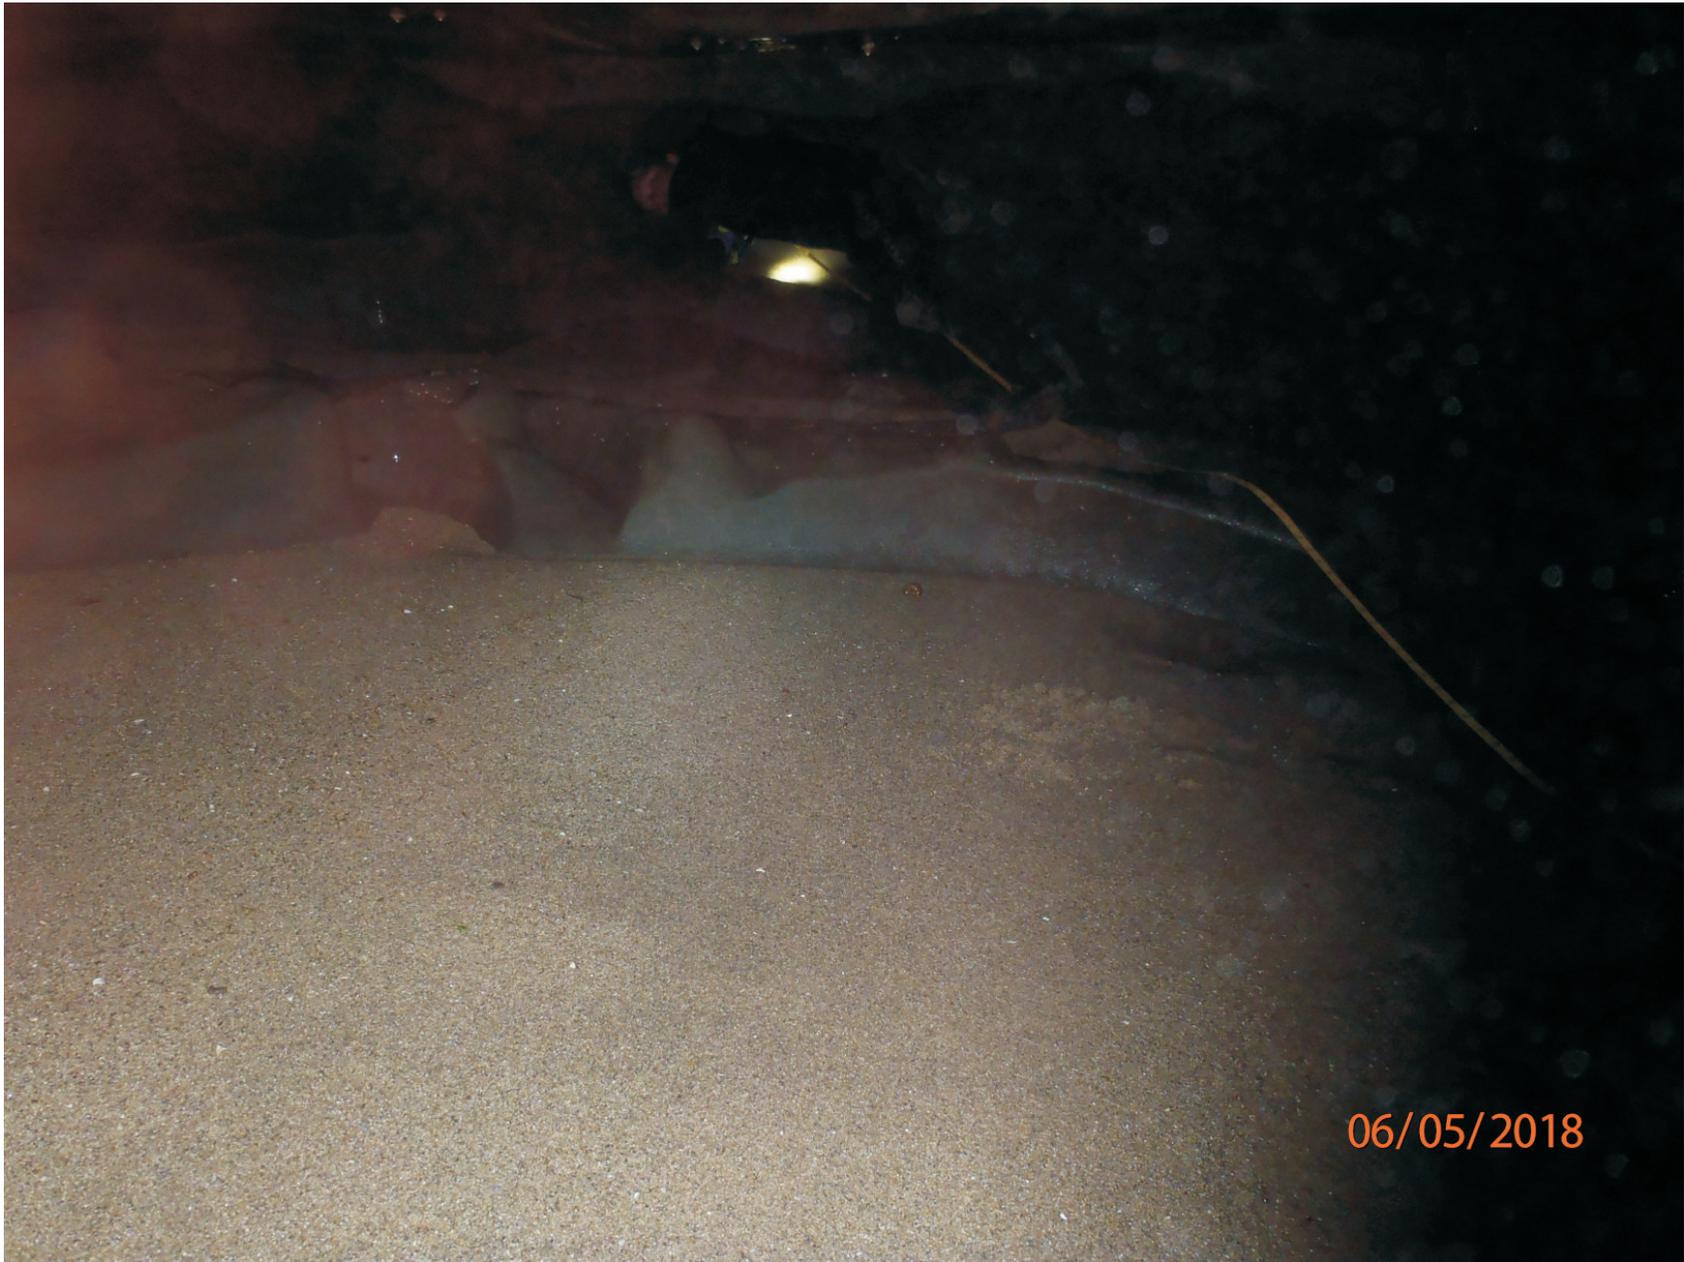
PHOTO NO.:
7

PHOTO 7: SOUTHWEST CAVE EXTENSION

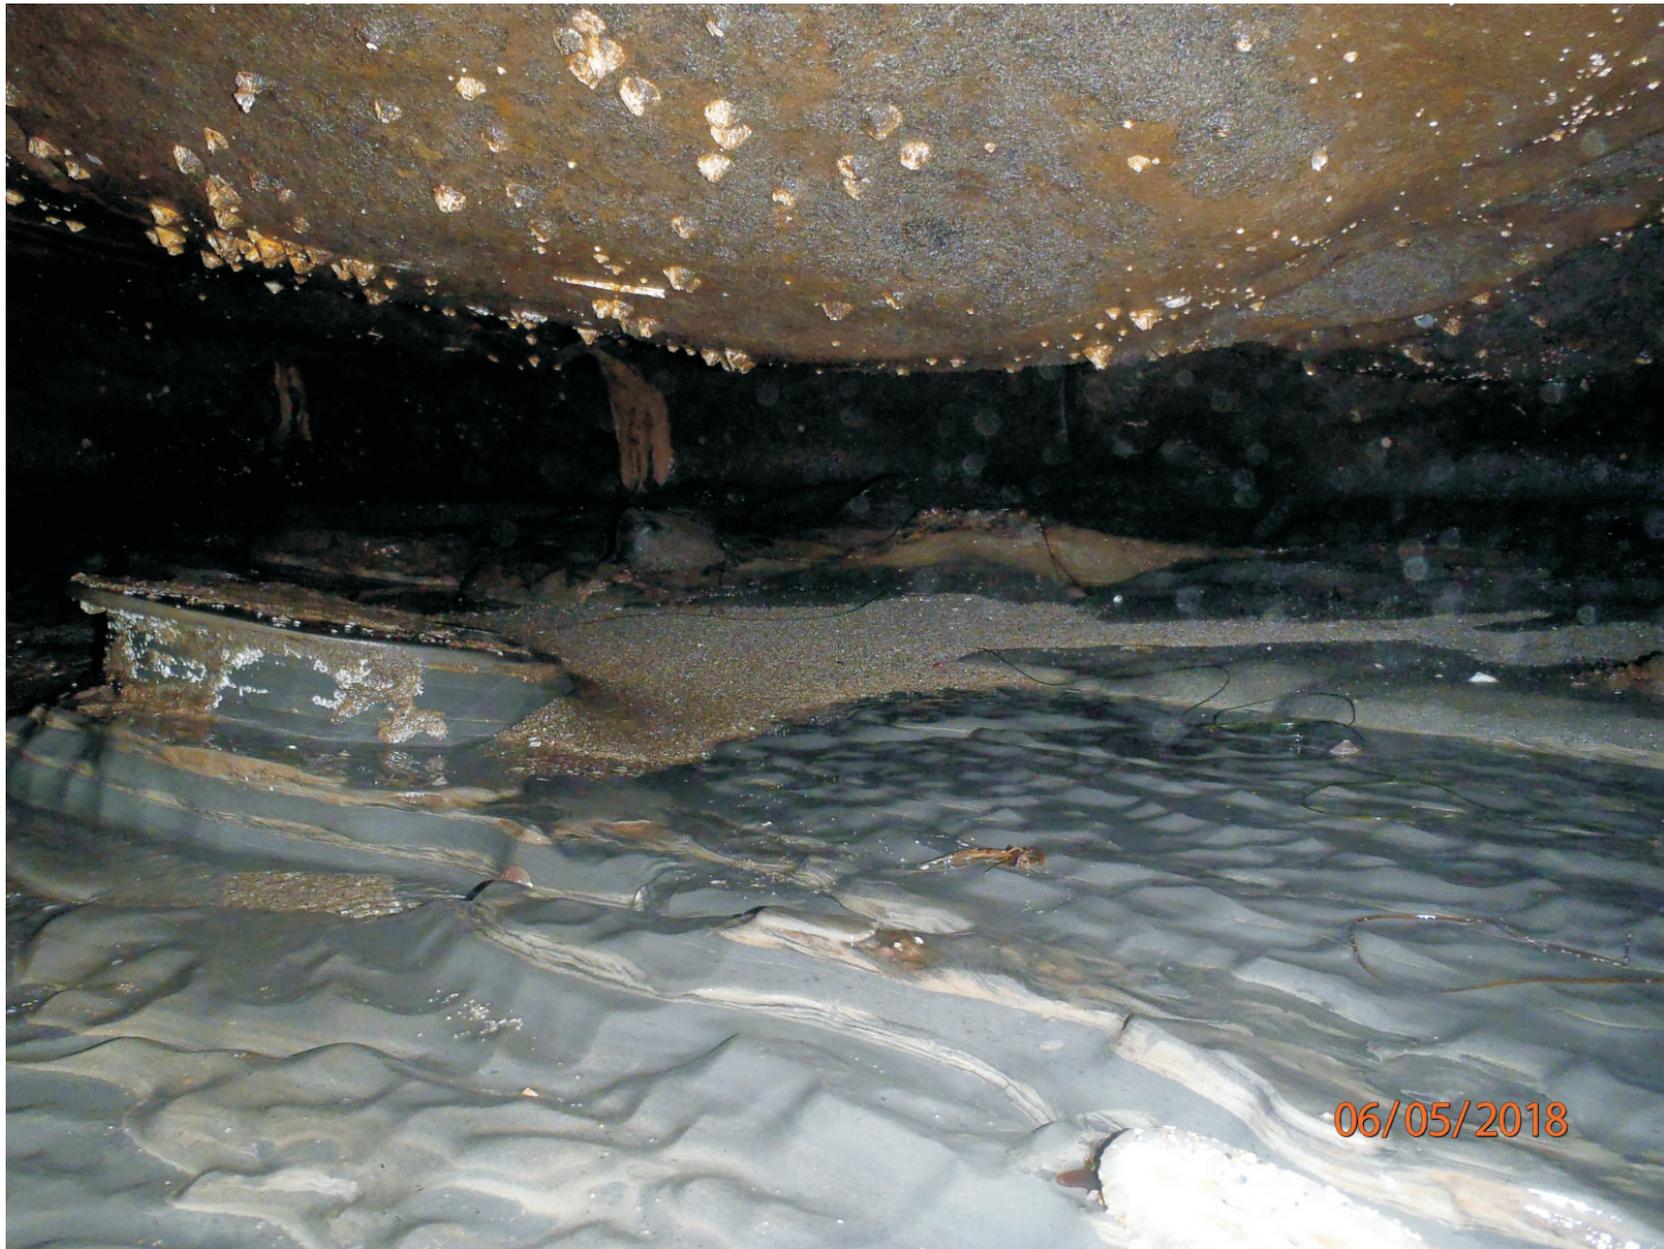
PHOTO NO.:
8

PHOTO 8: NORTHWEST CAVE EXTENSION
