July 16, 2020

SUBJECT: Comments on the April 16, 2020 Draft Environmental Impact Report for proposed "Hollywood Center" project. State Clearinghouse Number SCH 2018051002.

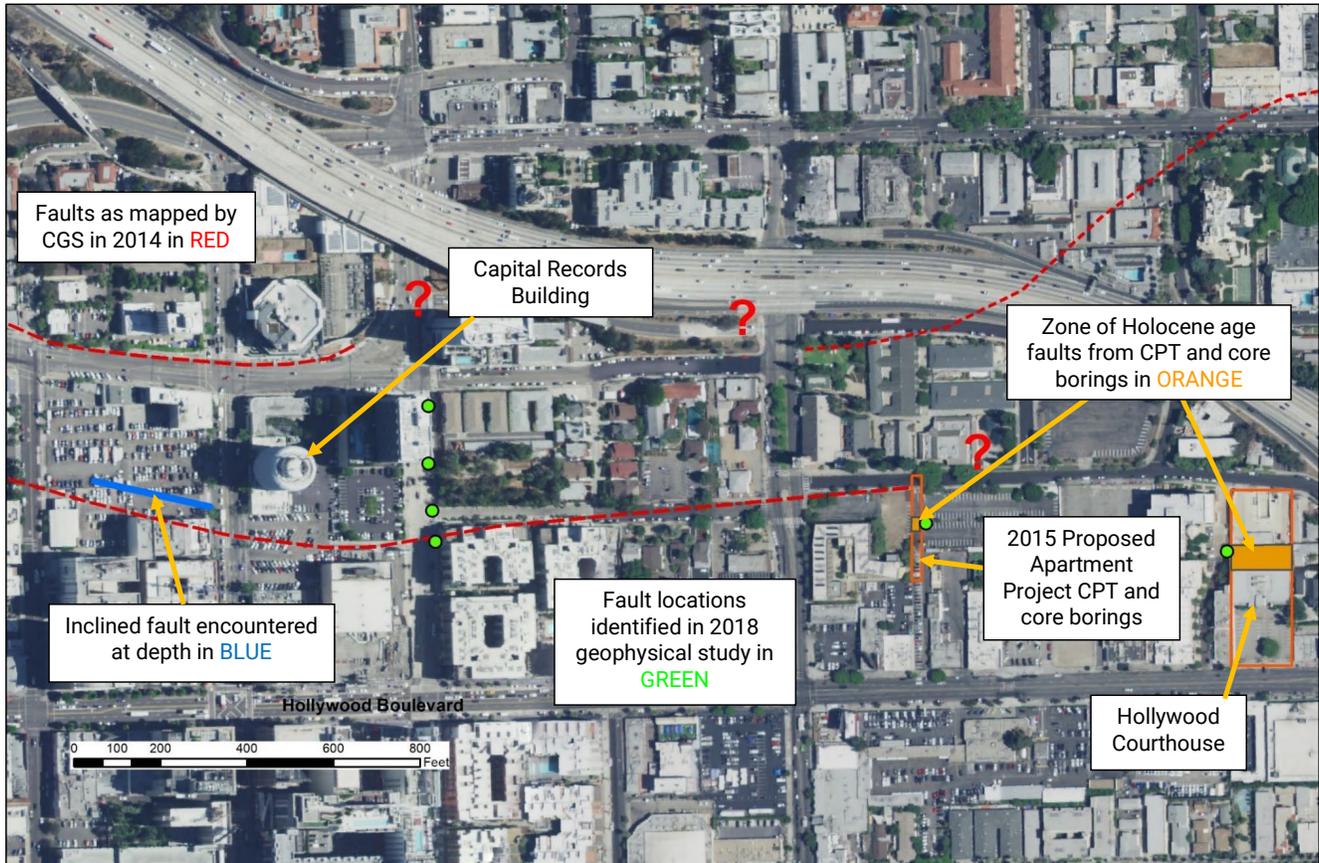
2. **The 2020 USGS study, and other studies that post-date CGS's 2014 Hollywood Fault Map, strongly suggest an active strand of the fault crosses the project site.** CGS considered the 2020 USGS study in light of other studies conducted after the 2014 Hollywood Fault Map. These studies are listed at the end of this letter and, for your convenience, are also available on CGS' FTP server ([FTP Link](#)). These studies, conducted east of the project site, postdate the studies included as Appendix G-1 to the DEIR, and are therefore new information of importance to public safety. These studies strongly support the presence of an active southern fault strand entering the eastern Hollywood Center property in the vicinity of the alley at Argyle, south of the

fault trench excavated in 2014 as described in Appendix G. Based on these studies, CGS expects to revise the Hollywood Earthquake Fault Zone Map within the next two years by extending the southern strand of the Hollywood Fault further east from where it is currently mapped.

Figure 1. Air photo image of the Hollywood area of Los Angeles with annotation by CGS. Red dashed lines are surface traces of active faults from the CGS Hollywood Fault Evaluation Report, 2014. Green dots represent locations where the Hollywood Fault has been located based on 2018 geophysical studies by the USGS. Orange rectangle inside the Hollywood Courthouse represents the location of the zone of faulting from a CPT and boring transect from Ninyo & Moore reports. Orange rectangle inside the Apartment project represents a zone of faulting from both CPT and core boring study by Group Delta. Blue line represents the steeply inclined Hollywood fault where it was encountered in Group Delta CPT and borings at depth.

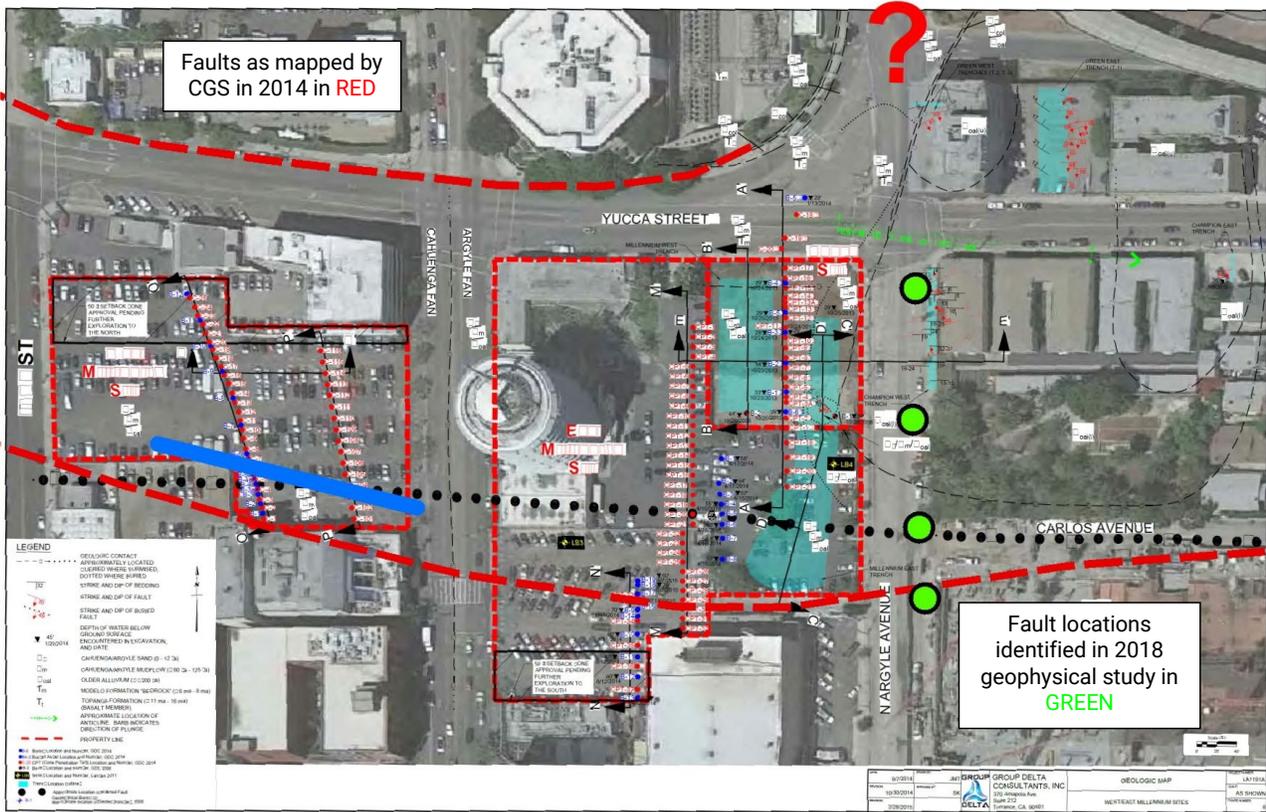
1. **Fault traces depicted in CGS's 2014 Hollywood Fault Map do not appear in Appendix G-1's figures of the project site** where locations of their subsurface investigations are presented. Therefore, we attach a figure showing both the location of traces as shown on the 2014 Hollywood Fault Map and the areas of investigation reported in Appendix G-1 (**Figure 1**). (DEIR Appendix G-2 shows the location of the fault trace at a lower level of resolution.) We note below that Figure 1 reflects new information indicating the active fault, which was not cleared by either the 2014 trench or the other investigative techniques reflected in Appendix G-1.

3. **The fault trench excavated in 2014 did not clear the entire site of active faults.** Based upon review of the information presented in Appendix G-1 of the DEIR, the GDC trench on the east property did not completely expose the base of the Holocene-age geologic section across the north-south extent of the site and therefore cannot be considered to exclude the presence of an active fault at or near where it is depicted in CGS's 2014 Hollywood Fault Map, or in the more recent studies mentioned above.

Figure 2. Google Earth image of the project location. Figure from Group Delta Fault Study Reports, as included in DEIR package with annotations by CGS. Turquoise shapes identify outline of approximate trench excavations at the ground surface. Trenches were excavated in vertical benches from the ground surface to selected depth. Excavation did not expose pre-Holocene materials across the entire length of the trench due to depth of excavation and benching style. Red and blue dots show core boring and Cone Penetration Test (CPT) locations across the site. Black dotted line is Group Delta's inferred fault trace, located at depth. Red long dashed lines are surface locations of active fault traces from CGS FER 253. Green dots represent locations where the Hollywood Fault has been located based on recent geophysical studies by the USGS. Blue line represents the steeply inclined Hollywood fault where it was encountered in Group Delta borings at depth.

In conclusion, further assessment of the southern strand of the Hollywood Fault, following, for example, best practices outlined in CGS Special Publication 42 as discussed above, is important to adequately understand seismic risks of the proposed development in light of recently available information.
