COASTAL EROSION ASSESSMENT AND
CAVE SOLUTION FEASIBILITY ANALYSIS
**COAST BOULEVARD AND
COOK'S CRACK SEA CAVE**
SAN DIEGO, CALIFORNIA

Project No. 2086B
June 17, 2019

GEOTECHNICAL SURVEY AND EVALUATION
COOK'S CRACK SEA CAVE
JUNE 28, 2018
BY TERRACOSTA

Project No. 2086A
June 28, 2018

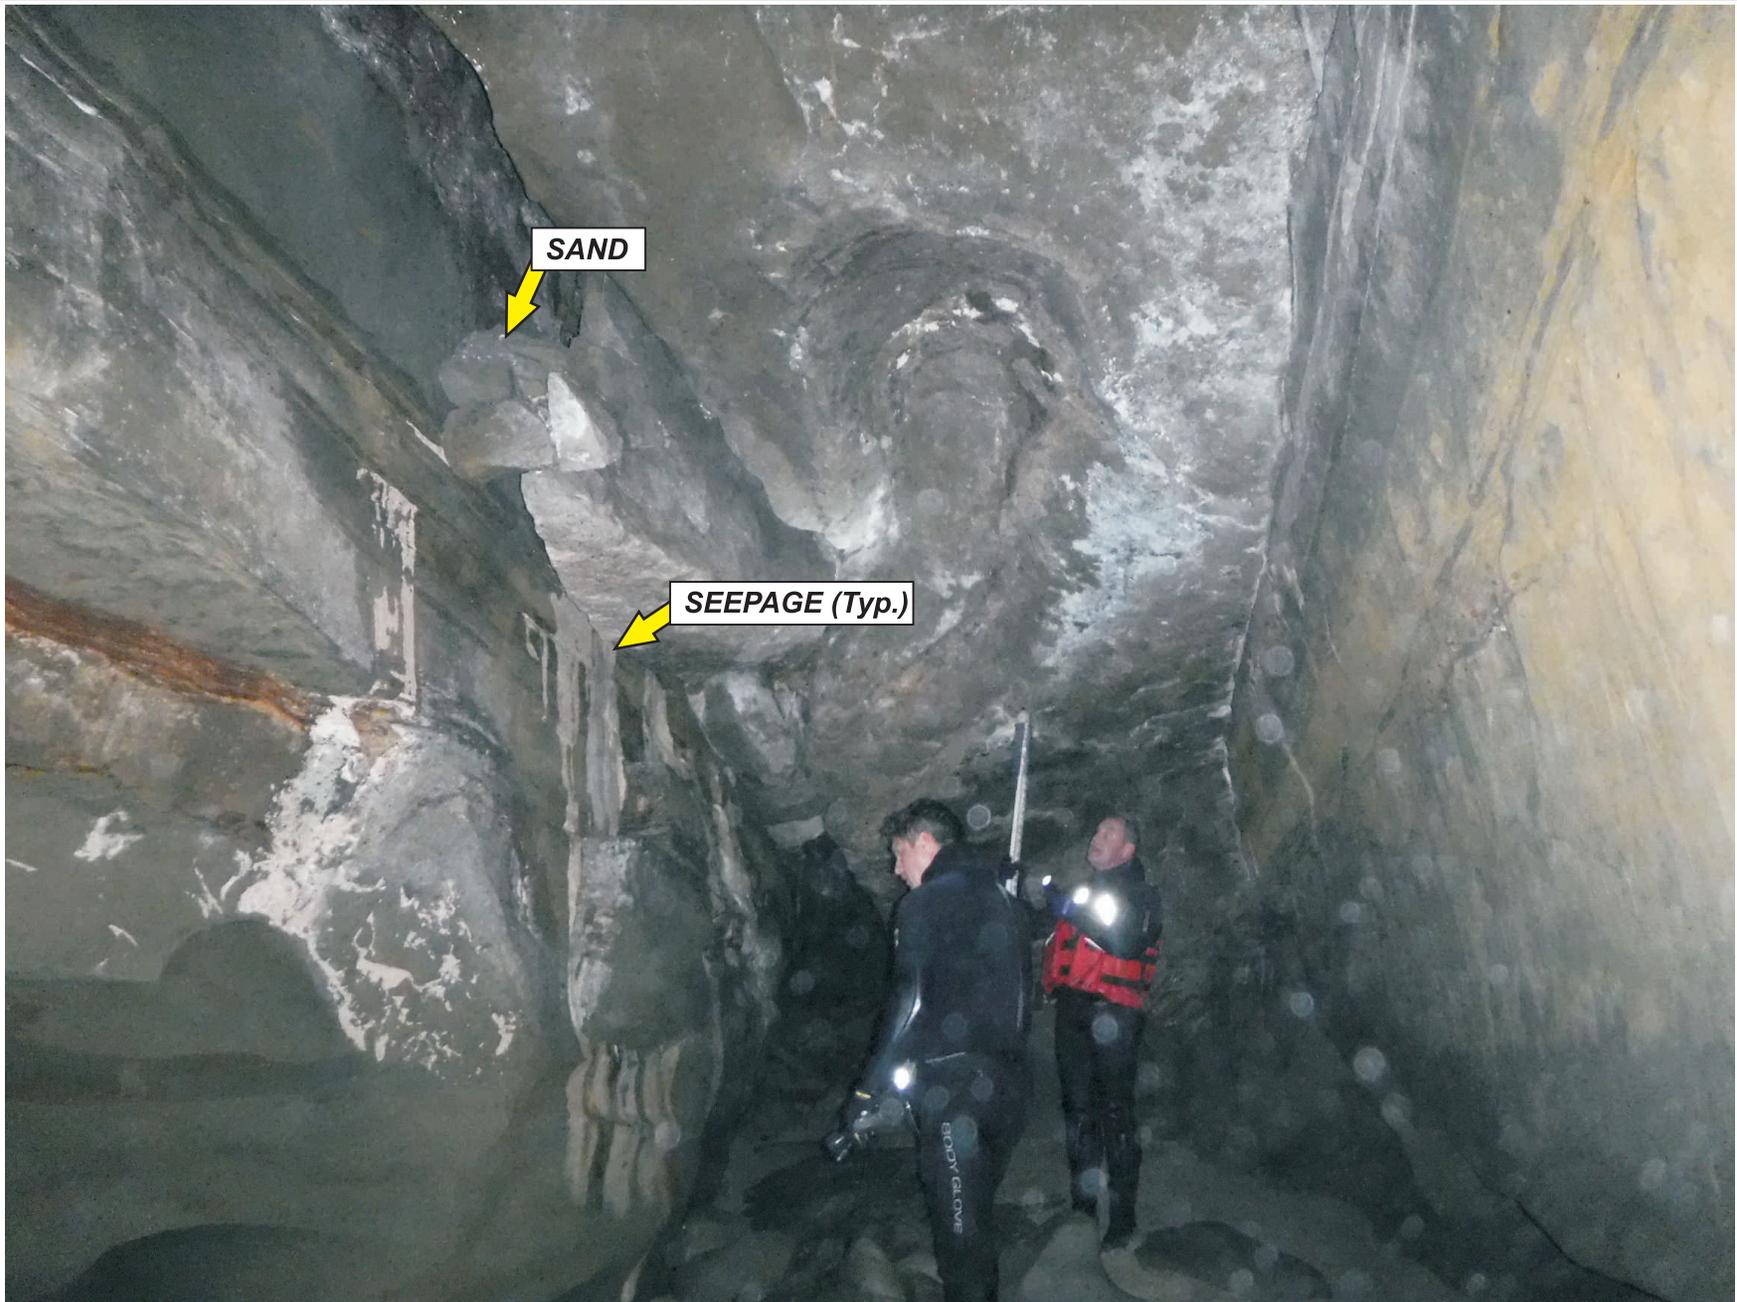
PHOTO NO.:
1

As indicated on Photo 1, the Cook's Crack Sea Cave is located on a cliffed section of the La Jolla shoreline, with the bathymetry immediately fronting the sea cave, although somewhat variable, around -3 feet MLLW. Photo 4, taken during our survey during a tidal low with the water level at about -0.2 foot MLLW, shows an indentation into the cliffed shore face of about 9 feet prior to actually entering the 4½-foot-wide mouth of the sea cave that is still not visible in Photo 4. The width of this indentation is also about 9 feet, and provides

We anticipate that the contractor would fill the cave in relatively horizontal lifts, and after the tops of the geobags have been reached, the exposed seaward face of the open jointed roof of the Cook's Crack Sea Cave (see Photo 1) would then be architecturally shaped to blend in with the surrounding formational bedrock to recreate the architectural appearance of the faulted roof rock. Once the cave is filled, the ten to twelve 4-ton rocks could be lifted back out of the mouth of the cave, returning the cliffed section to that shown in Photo 4.

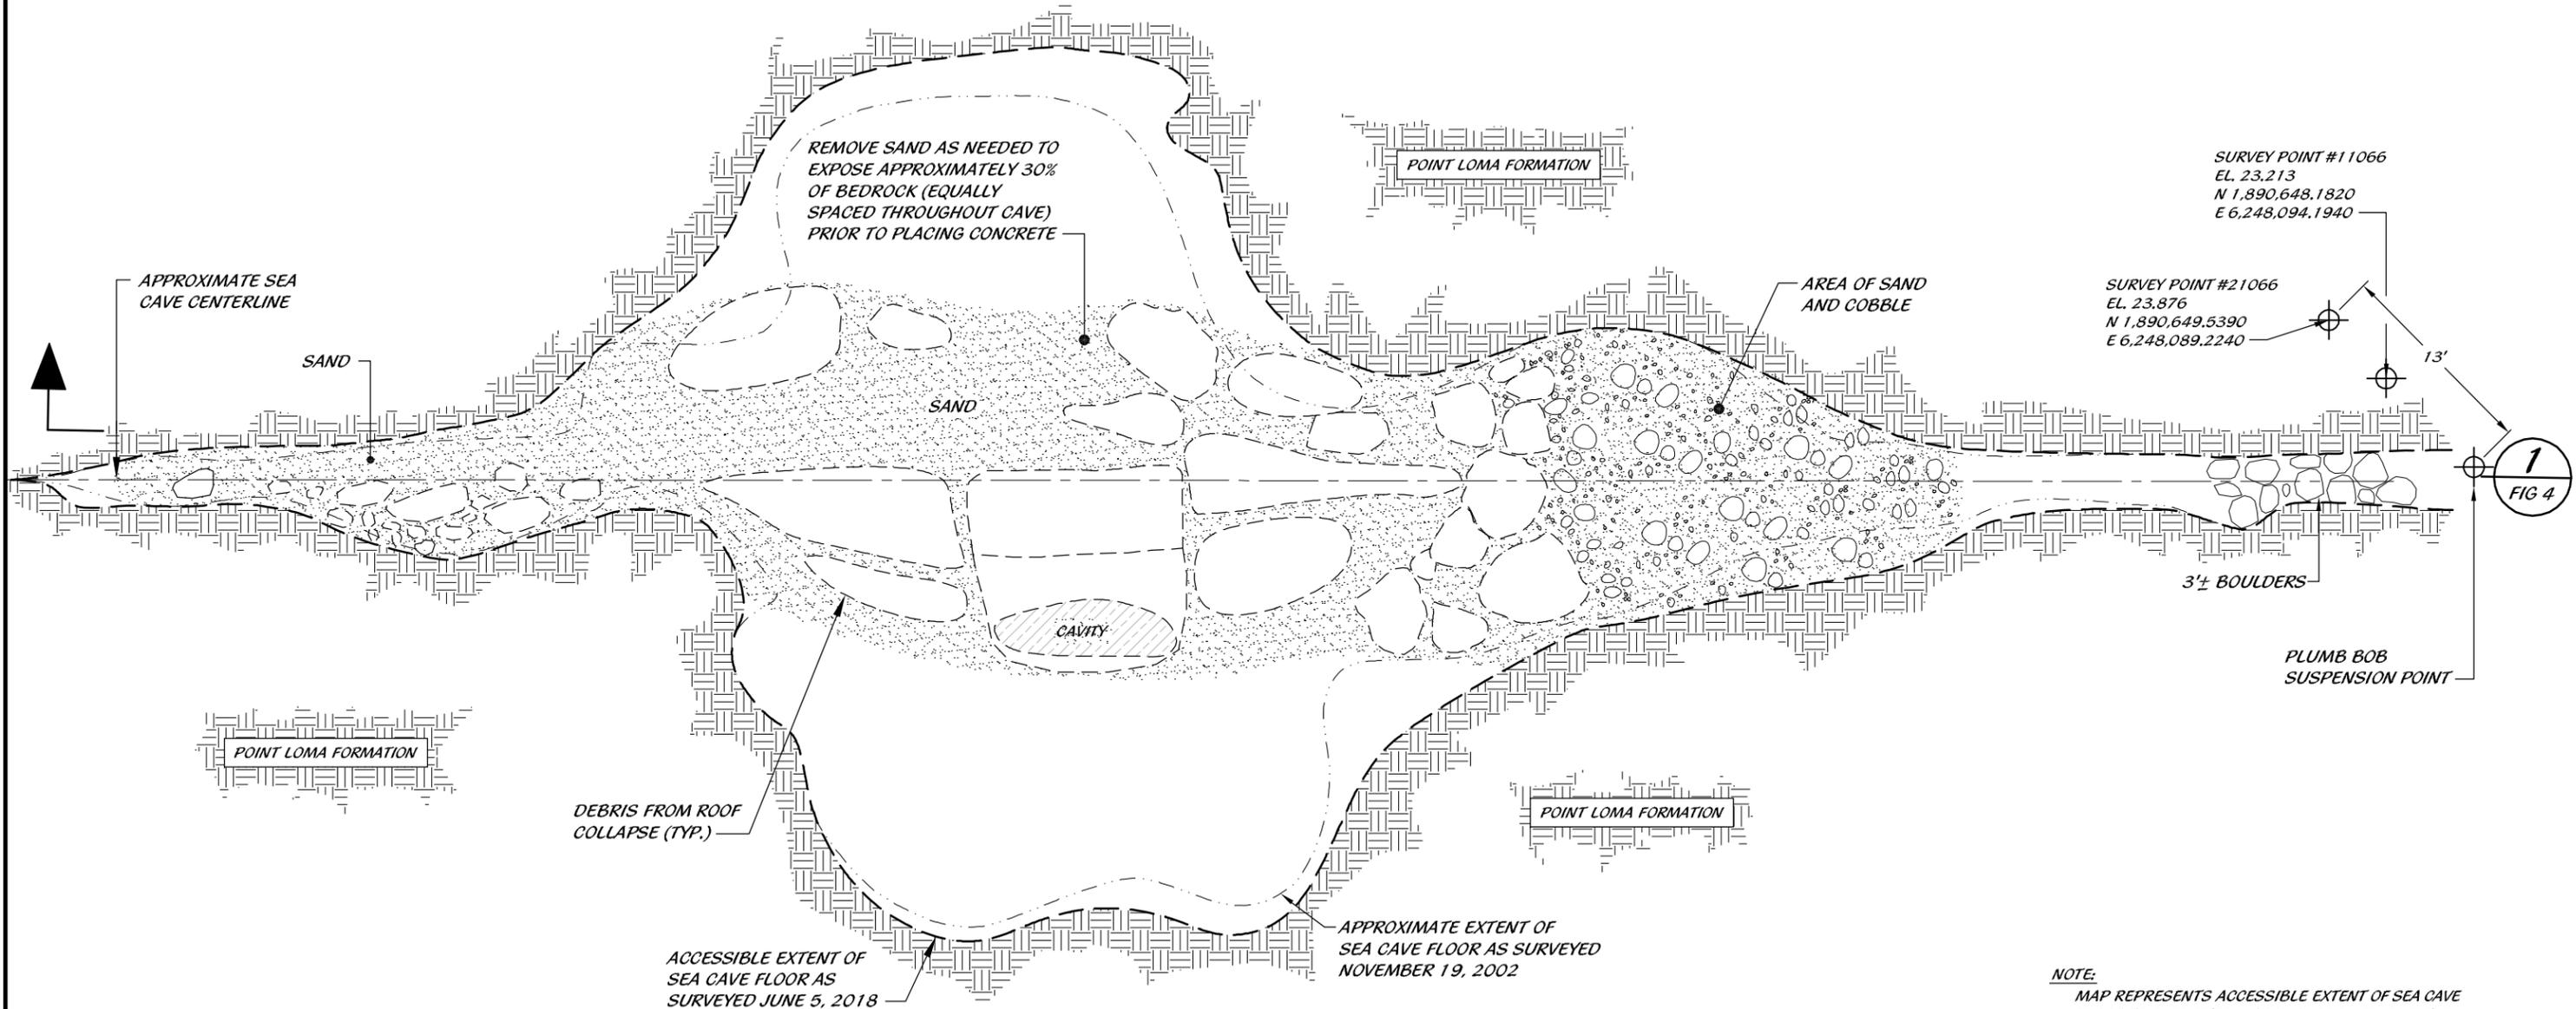
NOTE:
 MAP REPRESENTS ACCESSIBLE EXTENT OF SEA CAVE FLOOR AS SURVEYED MARCH 5, 2019, DURING THE TIDAL LOW OF -0.4 MLLW (APPROX. 3:00 p.m.)

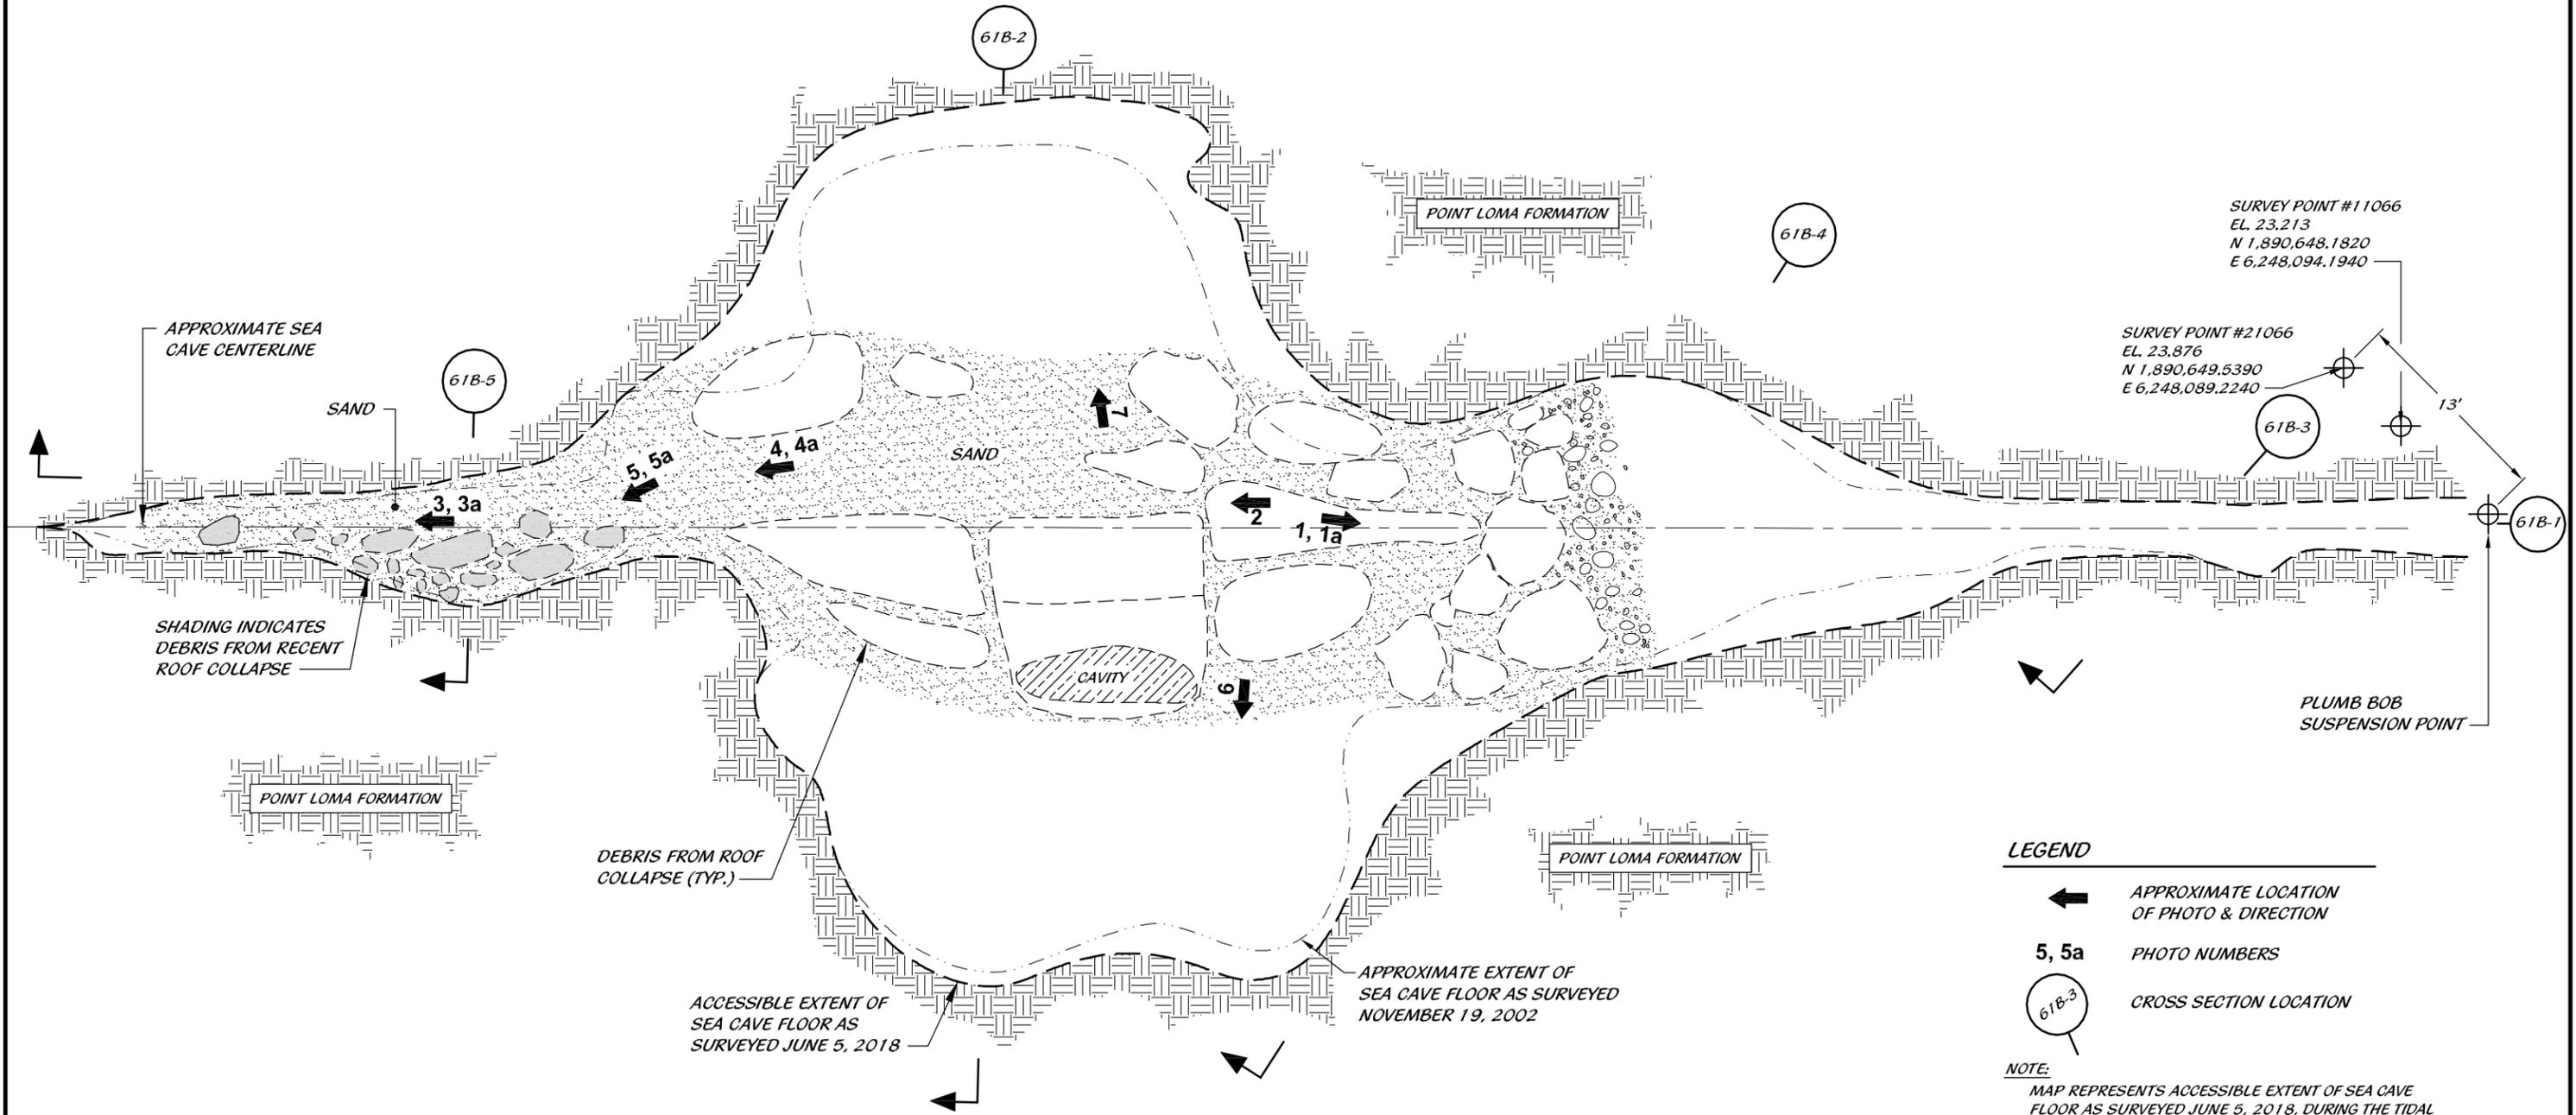
SITE PLAN

Our current survey indicates that as expected, the sea cave has widened approximately 6 to 8 feet (Figure 3) and continues to advance southerly under the sidewalk on the southerly side of Coast Boulevard, as shown on Figure 2. Figures 2 through 8 illustrate the current limits of the sea cave. Photos 2 through 8 are of the interior of the sea cave. It should also be noted that there is evidence of the widening of the fault, allowing the down-dropping of a smaller block, as illustrated on Figure 8 and discussed below in Section 5.

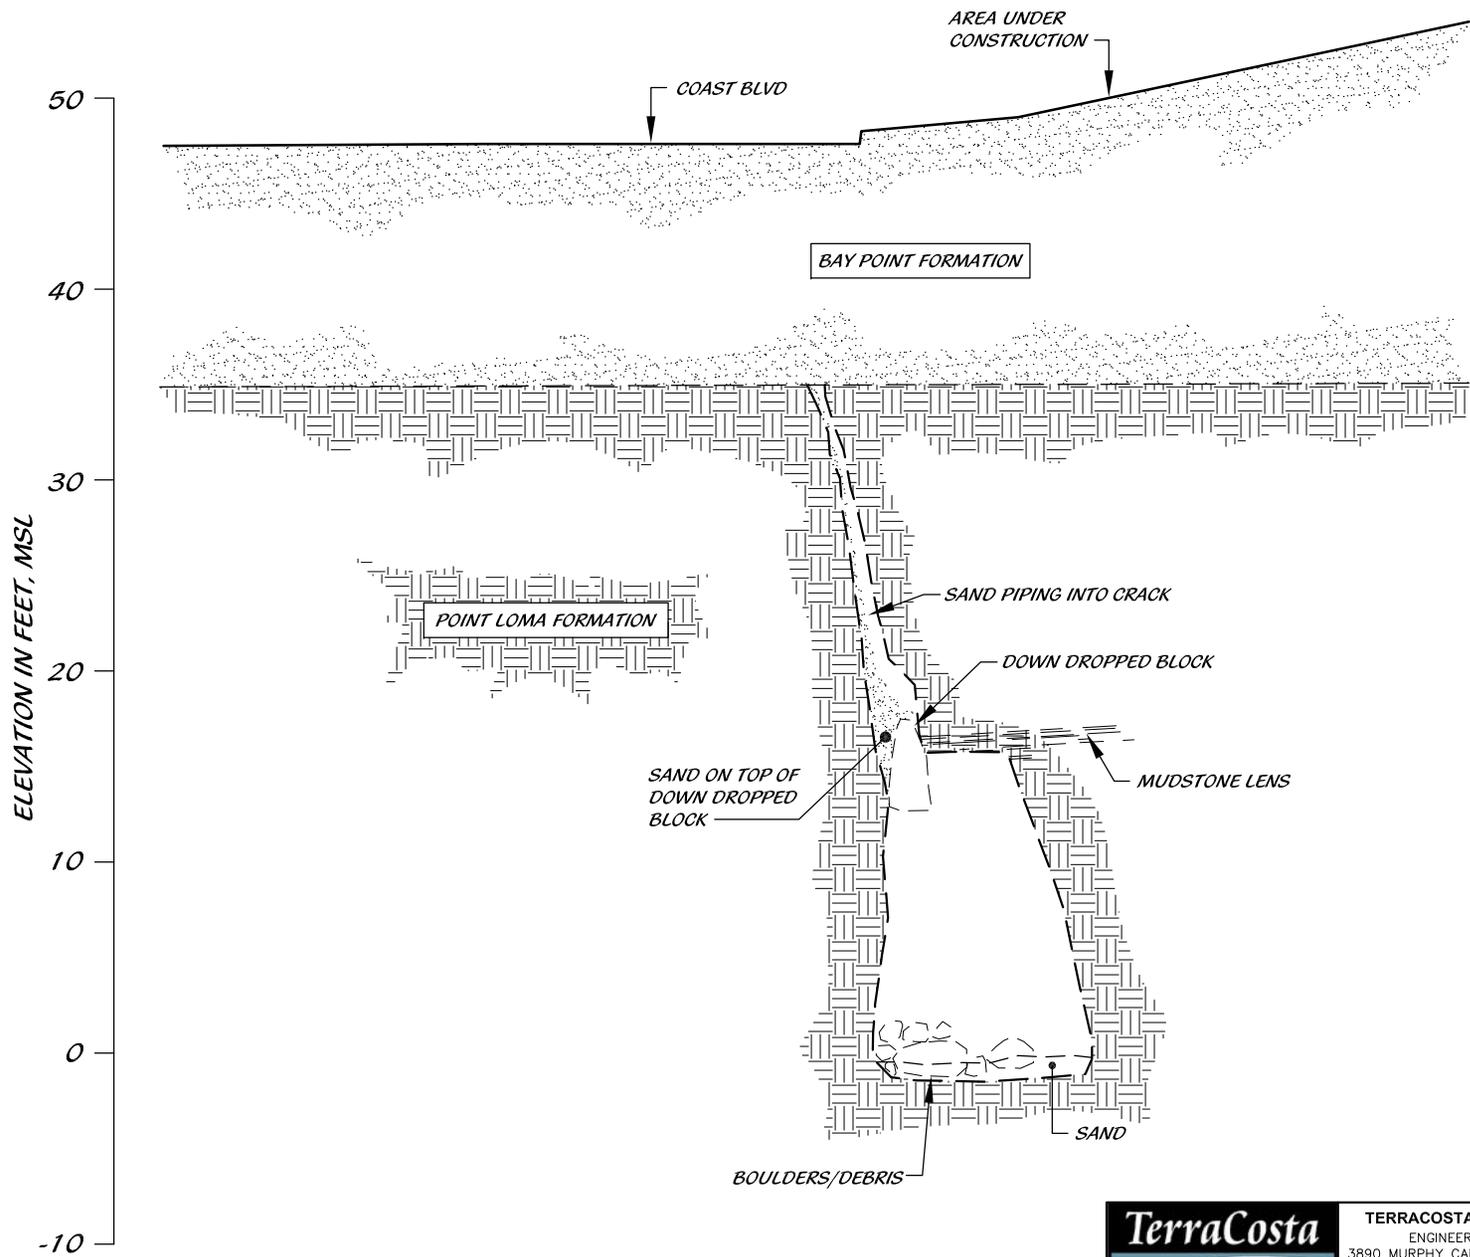
Formation soils through widening fractures into the sea cave. This mechanism is exhibited in Figure 8, with sands from the overlying terrace deposits now migrating through this underlying fracture. This lost ground will progressively worsen with time. Based on our recent observations, we recommend that the roadway over the sea cave be closely monitored for signs of settlement, and that the sea cave be inspected again in the next five years. It is also our opinion that a structural solution is necessary to prevent a future catastrophic failure.
